9.0 Lakeview, Oregon, Disposal Site

9.1 Compliance Summary

The Lakeview, Oregon, Disposal Site, inspected on July 10, 2007, was in good condition. Rock degradation monitoring of west side slope riprap indicated that the mean diameter of the riprap (2.32 inches) remains above the recalculated minimum size (1.8 inches). Plant abundance cover on the cell top has gradually increased over the years as patches of deeper-rooted shrubs have spread; however, at the time of the 2007 annual inspection the vegetative cover was slightly more stressed than in 2006 because of dryer conditions. Evaluation of the effects of deep-rooted vegetation on the performance of the disposal cell cover by modeling the movement of water through the radon barrier using water flux meters continues. An investigation of root intrusion and soil permeability has shown that tens to hundreds of centimeters of rainwater infiltrates through the cover during dry and wet years. No cause for a follow-up or contingency inspection was identified.

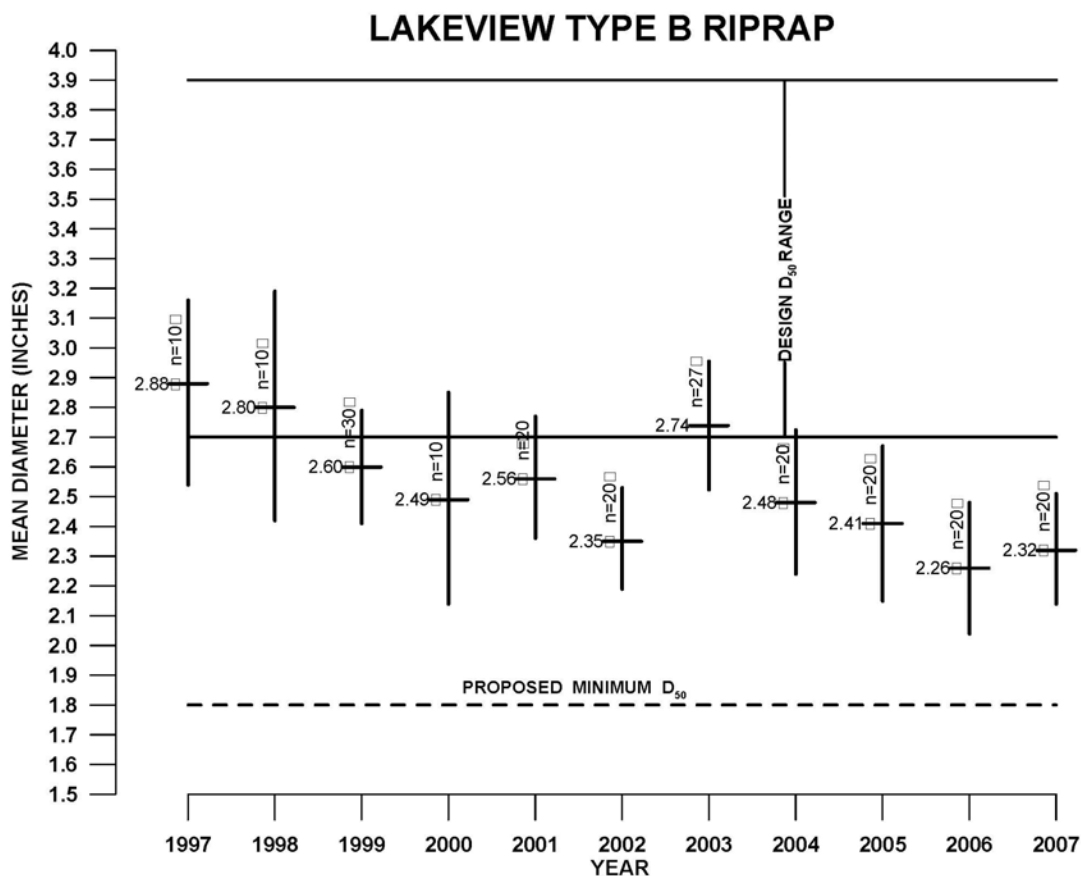
Figure 9-2. Side Slope Riprap Size Monitoring Results for the Lakeview, Oregon, Disposal Site

9C Annual rock degradation monitoring of side slope riprap was performed for the eleventh year during the 2007 inspection (PL-3). Particle size distribution (weight percent) by count data was collected at 20 locations. The 2007 results indicate a mean D_{50} of 2.32 inches with a 95 percent confidence interval between 2.14 and 2.51 inches (Figure 9-2). The mean D_{50} in 2006 of

2.26 inches was slightly smaller than the 2007 result. The D_{50} value measured for 2007 is similar to values measured for most of the previous 5 years: 2002 (D_{50} = 2.35 inches), 2003 (D_{50} = 2.74 inches), 2004 (D_{50} = 2.48 inches), 2005 (D_{50} = 2.41 inches), and 2006 (D_{50} = 2.26 inches). The mean D_{50} for the previous five years (prior to 2007) is 2.45 inches.

Detailed measurements of this erosional process began in 1997. Since that time the mean diameter has decreased about 20 percent. The D_{50} values measured for 2003 and 2007 show slightly upward or increasing trends, but the overall trend of D_{50} rock sizes from 1997 to the present suggests a gradual decrease in size. However, initially (1997 to 1999) the trend appeared to be more rapid than in more recent years. This initial more rapid decreasing trend may be because the basaltic rocks used on the side slope were predisposed to chemical or physical weathering and reacted more quickly to newly imposed surface conditions during the first decade (1989 to 1999) after cell completion. Therefore, the first decade of rock weathering may have seen the greatest and most rapid loss of rock integrity. The overall decrease in size may represent a minimum decrease in rock size because rock diameters are measured from surface samples and smaller fragments, derived from crumpling rocks, may have fallen into the interstices, thus producing a biased sample. Nevertheless, the current method of rock-size measurement has been performed for the past eleven years and does provide a consistent metric for cover material changes.

DOE will continue annual rock gradation monitoring of riprap to ensure that the side slopes of the disposal cell are protected from erosion. If it becomes apparent that the side slope riprap is continuing to deteriorate and that the measured D_{50} will eventually fall below 1.8 inches, DOE, in consultation with NRC, will evaluate alternatives and take corrective action, as necessary.

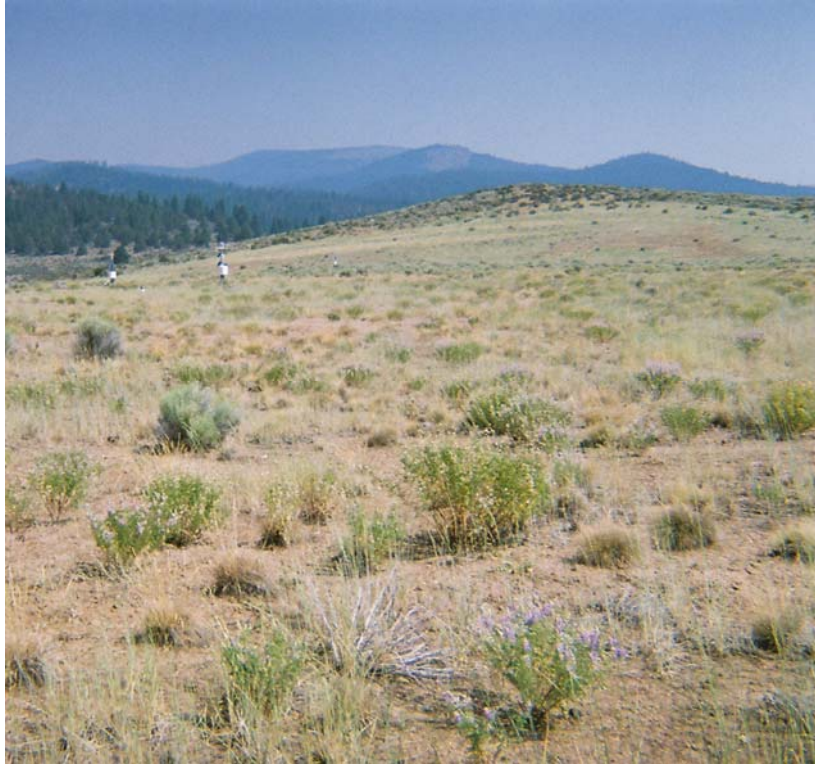
The top slope was seeded with grasses, but the low water-storage capacity of the thin (nominal 4-inch-thick) topsoil layer has limited grass growth to scattered patches of deeper-rooted wheat grasses. The total vegetative cell cover has gradually increased over the years as patches of deeper-rooted grasses have spread (PL-1); however, the vegetative cover was not as heavy in 2007 as in some previous years because of dryer conditions. Perennial and annual species, although limited, are also establishing on the cell top. Most of the top slope still has sparse vegetation compared to surrounding undisturbed plant communities.

Movement of precipitation through the riprap and bedding layers and into the radon barrier also favors the growth of shrubs. Sagebrush, rabbitbrush, and bitterbrush, which are the dominant plant species surrounding the site, have been establishing on the top of the disposal cell. During the 2007 inspection it was noted that the shrub density continues to increase. Shrub density likely will continue to increase until it approaches or exceeds levels observed in native plant communities adjacent to the site.

LKV 7/2007. PL-1. Vegetative cover on top of cell.

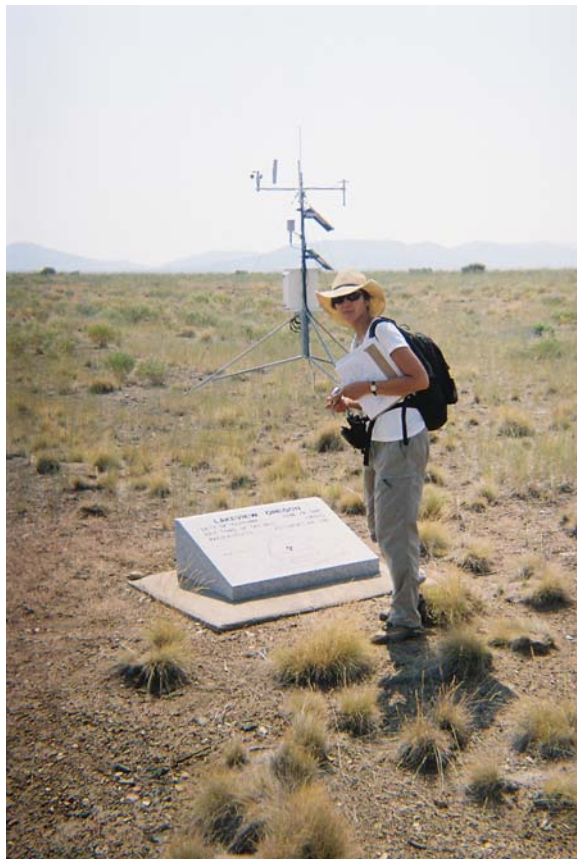
Site Markers and Monuments—The two site markers, three survey monuments, and three boundary monuments were in excellent condition.

LKV 7/2007. PL-2. Site marker SMK-2 and meteorological station in background.

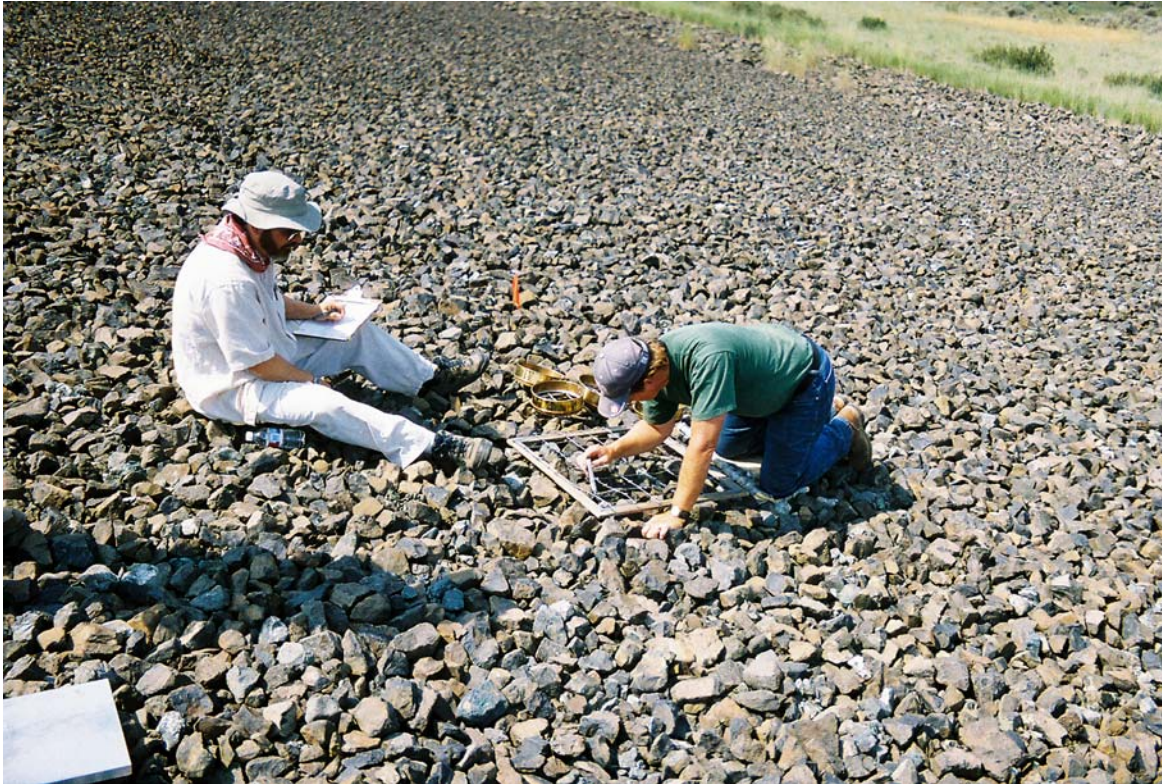
LKV 7/2007. PL-3. Rock measurements on side slope.

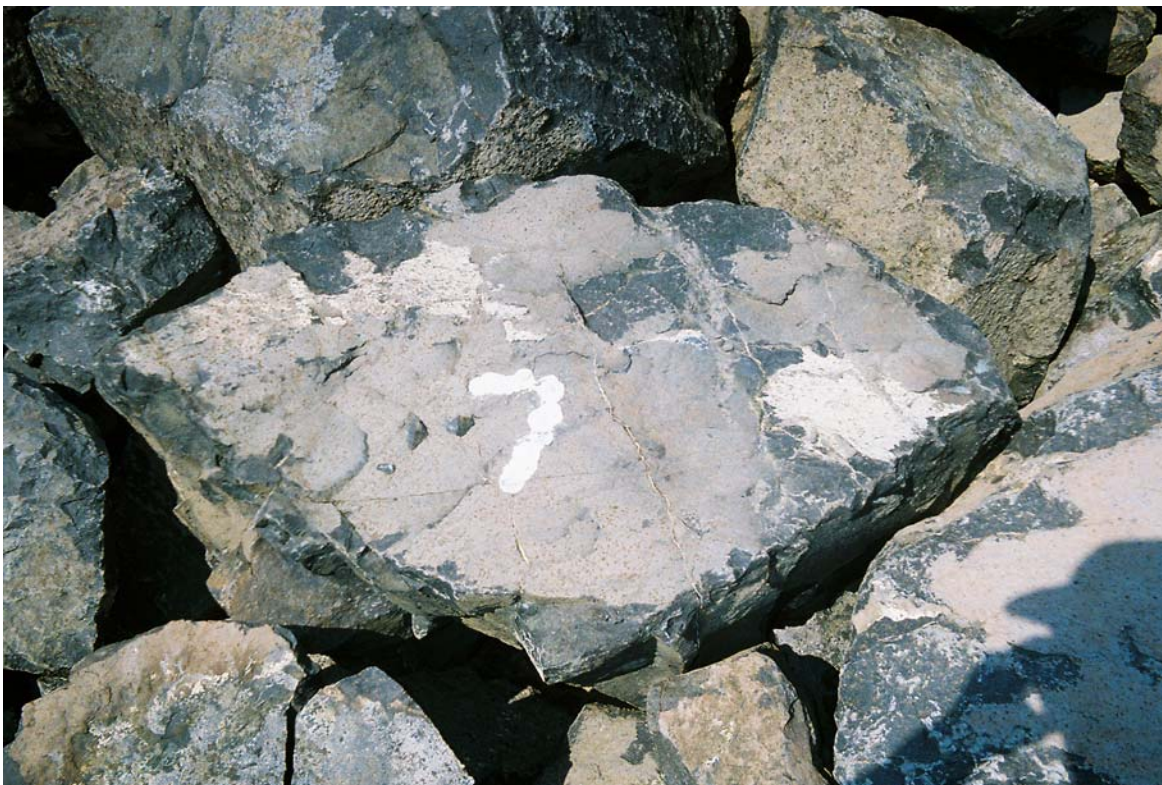
In addition to the side slope riprap monitoring discussed above, DOE also performs long-term monitoring of riprap at a second location (the energy dissipation area) through the use of annual comparative photographs. Eighteen points in the energy dissipation area were re-photographed (PL-4). Minimal rock degradation has been observed since monitoring began at the original ten locations established in 1997 or at the eight additional locations established in 2000.

LKV 7/2007. PL-4. Riprap monitoring location 7 at the energy dissipation area.
